DESIGN OF READYMADE GARMENTS INDUSTRY FOR FIRE SAFETY

A Dissertation for the Degree of Master in Disaster Management

By
AHSAN FIROZ
10268004

Postgraduate Programs in Disaster Management (PPDM)
BRAC University

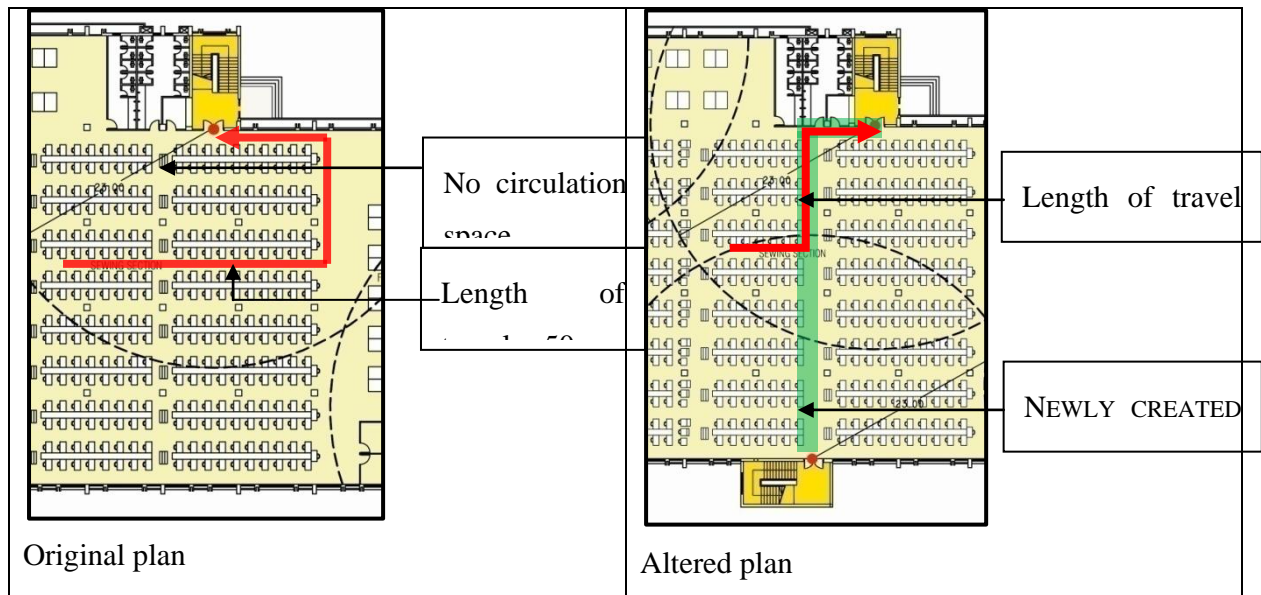
Figure 80, Original and altered plan of core area of Case Study 02

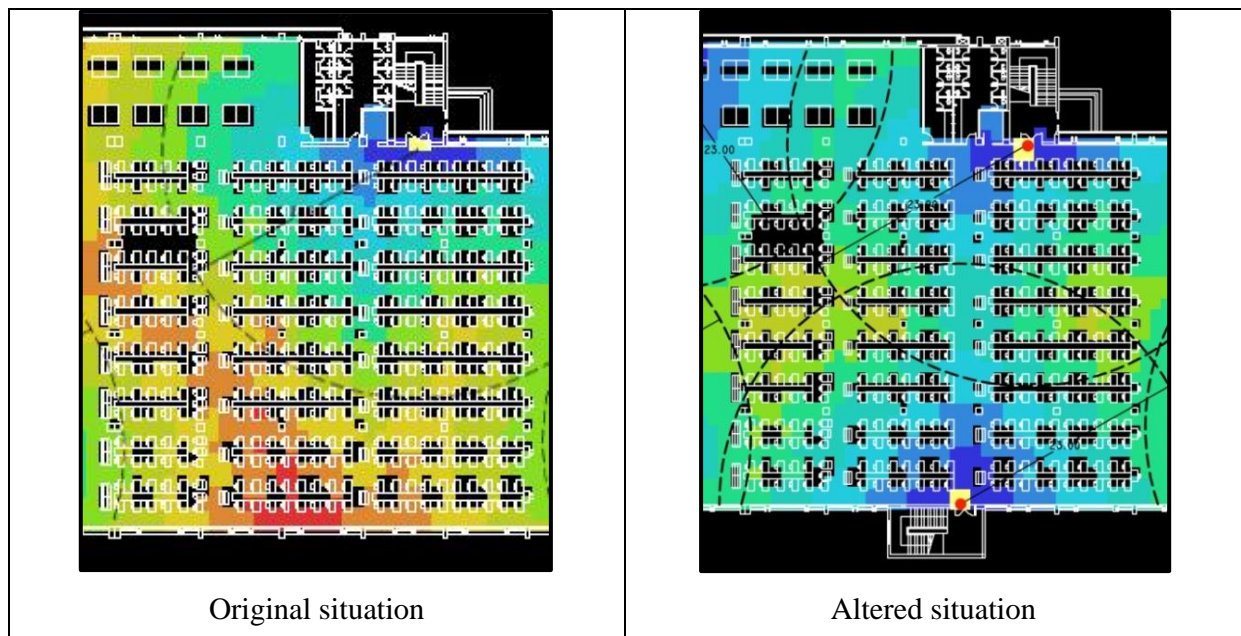
Figure 81, Metric step depth analysis of original and altered plan of Case Study 02 (core area)

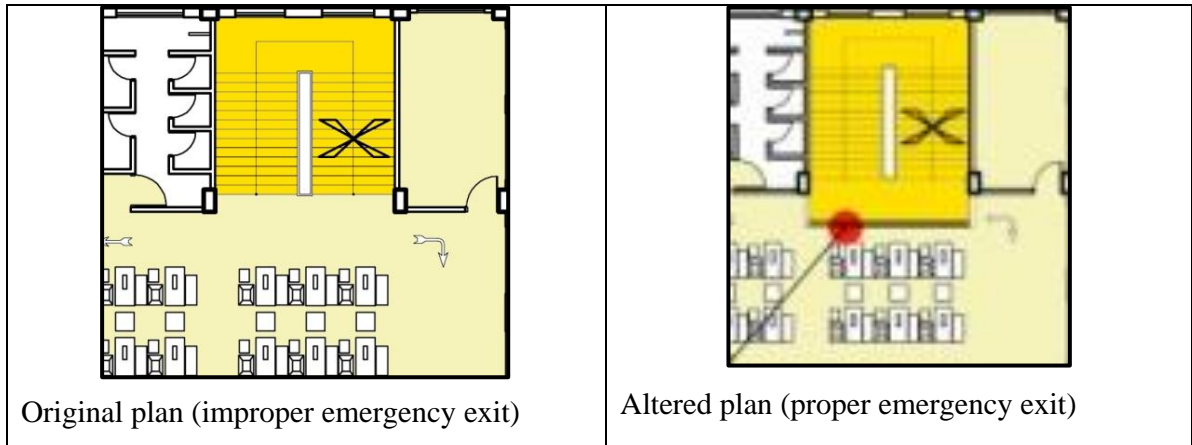
Figure 82, Improper and proper emergency exits
